## Performance Improvement of the Ceramic Outdoor Insulators Located at Highly Polluted Environment Using Room Temperature Vulcanized Silicone Rubber Coating

Fari Pratomosiwi and Suwarno

**Abstract:** Ceramic insulators are widely used in transmission as well as in distribution lines. As outdoor insulators, the ceramic insulators are subjected to environmental stresses. In particular case, the insulators may severe high pollution exposure. Under the polluted condition, high leakage current will flow on the insulator surface and dry band arching may take place. The phenomena may initiate the insulator flash over leading to the failure of the lines. Several efforts may be taken to improve the insulator performance under polluted condition. Recently, adding of hidrophobic agent on the insulators was introduced to improve the performance of ceramic insulators under polluted condition. This paper reports the experimental results on the application of room temperature vulcanized (RTV) silicone rubber coating on the medium voltage ceramic insulators under various environmental conditions. The samples were put in a test chamber with controlled humidity and pollution condition. The charac

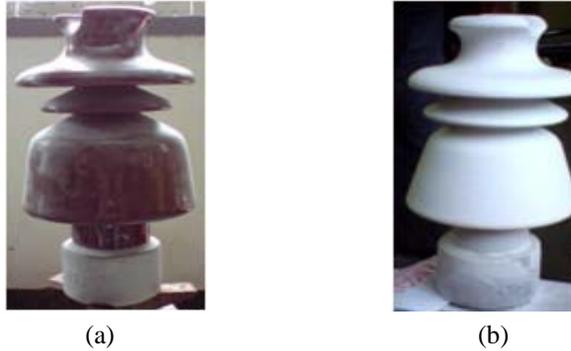
Figure 1. Pictures of non coated (a) and RTV coated (b) samples

Post pin ceramic insulators with 20 kV operating voltage were used as samples. The samples were coated with silicone rubber by using high pressure nozzle with thickness of about 0.3 mm.

The RTV silicone rubber coating materials were made by Dow Corning. The pictures of the samples are shown in Figure 1. A test chamber made from aluminium panel with size of 90 cm x 90 cm x 120 cm was used to simulate pollution exposed to the samples. The front opening of the test chamber was made from acrylic to facilitate the observation of arcing on the sample surface.

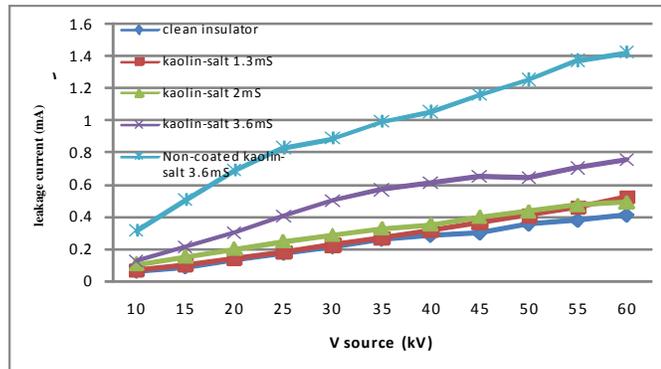
Figure 2. LC magnitude as function of applied voltage for insulator polluted with various kaolin-salt pollution under clean fog

Figure 2 shows the dependencies of leakage current for clean sample and kaolin-salt polluted samples on the applied voltage for both RTV Silicone Rubber coated and non-coated insulator. It is clearly seen that LC magnitude increase almost linearly with the applied voltage. Figure 2 also shows that the LC magnitude greatly affected by the different pollution levels applied on the samples. On applied voltage 10 kV, it can be seen that the LC magnitude almost the same for clean sample and kaolin-salt samples. Along with the increasing of applied voltage, the LC magnitude of kaolin sample is higher than the clean sample. The amounts of salt applied also affected the LC. The greater amount of kaolin-salt pollution caused higher LC magnitude. At 60 kV, the highest LC magnitude flowed on insulator polluted with kaolin-salt pollution at 3.6 mS and the lowest LC magnitude flowed on clean sample. The greater amounts of kaolin-salt pollution increase the surface conductivity. Conductive surface caused the LC flowed on insulator surface increased. It can also be concluded from Figure 2 that LC magnitude of insulator with greater amount of pollution has greater gradient as a function of applied voltage. We can also see from Figure 2 that LC magnitude of non-coated ceramic insulator much higher than LC of RTV Silicone Rubber in the same experimental condition (kaolin-salt 3.6 mS). It means that the RTV Silicone Rubber coated suppressed the magnitude of leakage current flowed. It also means that RTV Silicone Rubber coated can maintain surface resistance since the LC magnitude for various polluted conditions almost the same. This phenomenon does not happen for the non-coated ceramic insulators which cannot maintain its surface resistance under polluted conditions.

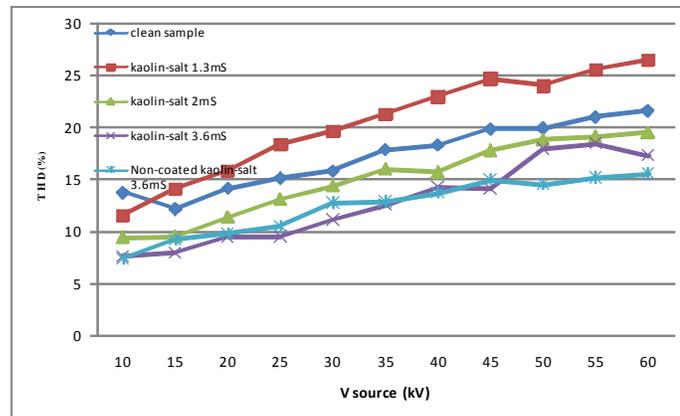
Figure 3 shows the dependencies of total harmonic distortion (THD) of LC waveform on the applied voltage and the amounts of kaolin-salt pollution. It is clearly seen that THD increase with the applied voltage. However, Figure 6 also indicates that THD value for kaolin-salt polluted insulator under clean fog was decreased together with the increasing amounts of pollution applied. This is due to the increase of surface conductivity and reduction of electric field. This phenomenon also applied for the non-coated ceramic insulators.

Figure 3. THD as function of applied voltage for insulator polluted with various kaolin-salt pollution under clean fog

These results indicate that RTV silicone rubber coating improves the performance of ceramic outdoor insulator. RTV silicone rubber coating suppressed the magnitude of leakage current, the harmonic content of leakage current and increased the flashover voltage. The low LC corresponds with high surface resistance which indicates high quality of insulator.

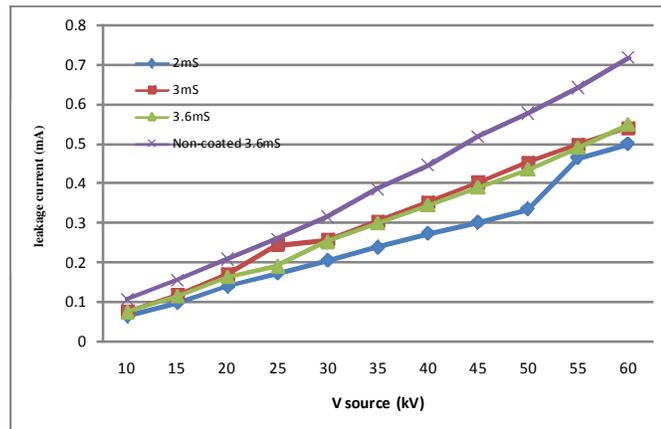
Figure 4. LC magnitude as function of applied voltage for insulator polluted with kaolin-pollution under salt fog with various conductivity

Figure 4 shows the dependencies of LC magnitude on applied voltage for kaolin polluted under salt fog with conductivity of 2, 3, and 3.6 mS. The LC magnitude increase linearly together with the applied voltage. Figure 4 also shows the magnitude of leakage current is almost equal under various salt fog conductivity of 2, 3, and 3.6 mS. It can be seen that salt fog conductivity did not affect the magnitude of LC since the magnitude of LC under various salt fog conductivity was almost the same. Compared to the LC magnitude under clean fog, the LC magnitude under salt fog was almost equal. Figure 4 also shows the LC magnitude for non-coated ceramic insulators higher for salt fog conductivity of 3.6 mS. It means that salt fog conductivity affect the magnitude of LC since the LC magnitude increased along with increased in salt fog conductivity [4].

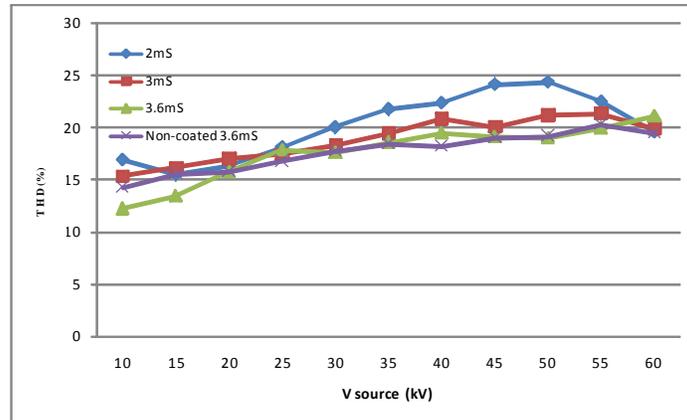
Figure 5 indicates that the THD of kaolin polluted under salt fog were almost equal for conductivity of 2, 3, and 3.6 mS. The THD increases slightly with applied voltage. Meanwhile, the THD for non-coated ceramic insulators reduced along with the increase of salt fog conductivity. This is due to the increase of surface conductivity. However, this phenomenon did not occur with RTV silicon rubber coating because salt fog conductivity did not increase the surface conductivity. Therefore the THD value was not decrease along with salt fog conductivity.

Figure 5. THD as function of applied voltage for insulator polluted with kaolin- pollution under salt fog with various conductivity

The results can be explained as follows. Because of RTV silicone rubber coating, the increase of salt fog conductivity did not affect the surface conductivity. Usually for the non-coated ceramic insulator, kaolin polluted surface exhibit a hydrophilic property.

Under salt fog with high conductivity, the kaolin is trapping the salt water and drastically increases the surface conductivity. This process enhances the current to flow on the insulator surface. However, the most important property of RTV silicone rubbers for insulator coating is their retention of water repellence [5]. The silicone rubber give water repellence to the polluted surface because low molecular weight silicone fluid that diffuses from the bulk of the coating surrounds contaminants with a monolayer of fluid that imparts a non-wetting property, or hydrophobicity, to the contaminant layer. In addition, the monolayer of fluid which surrounds the contaminant also inhibits dissolution of the contaminant in water. As a result, the electrolytic layer that develops is weak and not conducive to the development of leakage current and flashover. So it be concluded that the salt fog conductivity do not affect the LC magnitude as well as its harmonic content of ceramic insulator coated with RTV silicone rubber.

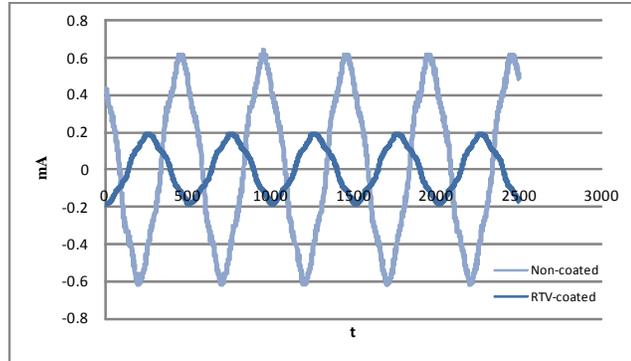
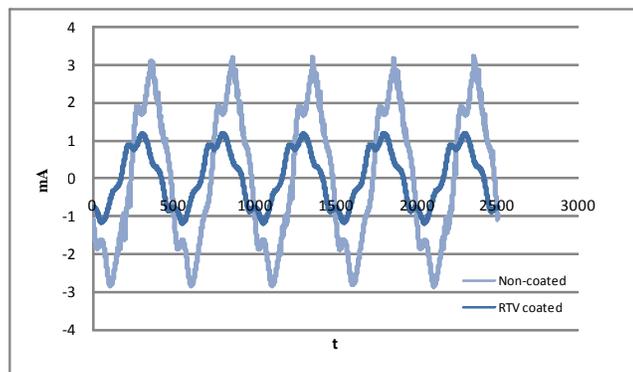
Leakage current for samples at clean fog condition: Figure 6 compared typical leakage current waveforms for RTV Silicone Rubber coated insulator and non-coated ceramic insulator for kaolin-salt polluted under clean fog at applied voltage (a) 10 kV, (b) 40 kV and (c) 60 kV. The waveforms slightly distorted from their sinusoidal due to presence of harmonic components especially 5th component.

Figure 6. Typical LC waveforms for insulator polluted with kaolin-salt pollution under clean fog at applied voltage (a) 10 kV and (b) 60 kV

For RTV Silicone Rubber coated insulator, at applied voltage from 10 – 60 kV, the leakage current waveform distortion was symmetrical at both polarity (positive and negative half cycles) and the 5th harmonics greatly contributed to the THD. On the contrary, the 3rd harmonic component was not significant for polluted insulator with kaolin-salt pollution at 3.6 mS. The greater amounts of kaolin-salt pollution applied may increase the surface conductivity. Therefore at kaolin salt pollution at 1.3 mS and 2 mS the insulator surface were not very conductive caused the THD value larger than for kaolin salt pollution at 3.6 mS. Those are because at small amounts of kaolin-salt polluted, the 3rd harmonic more significant.

On the contrary, for non-coated insulator, at applied voltage from 40 – 60 kV, the leakage current waveform distortion was asymmetrical. Spark was observed in positive half cycles. The 5th harmonics greatly contributed to the THD. Meanwhile the 3rd harmonic component is still insignificant.

It is reported that the appearance of arcing of 3rd harmonic is always insignificant until an arc present on the surface of insulator [7]. Since the arcing was not observed in the experiment, and the 3rd harmonic component is insignificant, we can fully agree with the statement.

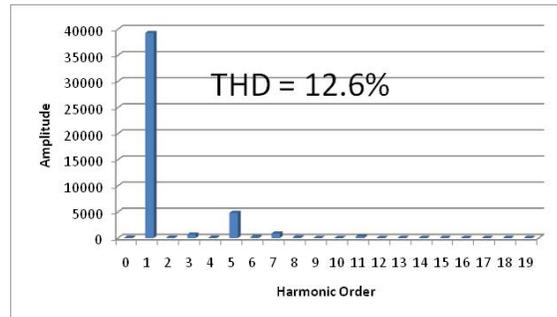
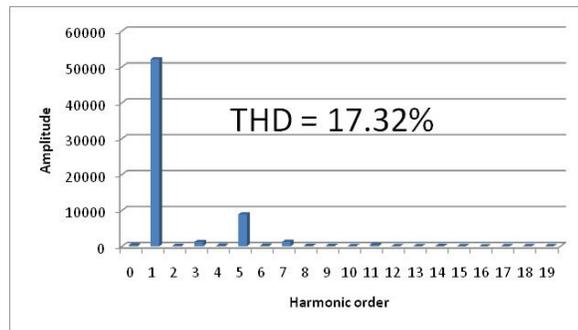
From Figure 7, it is clearly seen that the 3rd harmonic is small compared to 5th harmonic. The 3rd harmonic component was not larger along with the increase of voltage applied. This fact can be explained as follows. As applied voltage, usually ionization takes place on the insulator surface. Electric discharges take place if initial charge or electron is available and the instantaneous applied voltage exceeding a certain threshold value. However, this phenomenon did not occur on RTV silicone rubber surface because there electric discharges did not take place and maybe the instantaneous applied voltage did not exceed the threshold value because it is very high.

Figure 7. Typical harmonic components for insulators polluted with kaolin-salt pollution under clean fog at applied voltage (a) 40 kV and (b) 60 kV

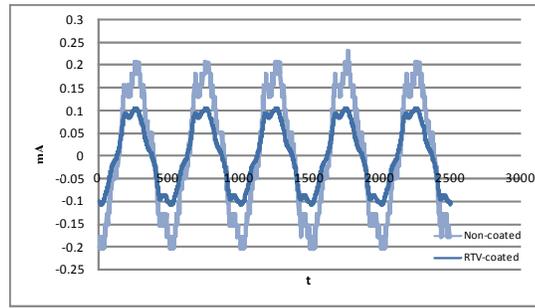
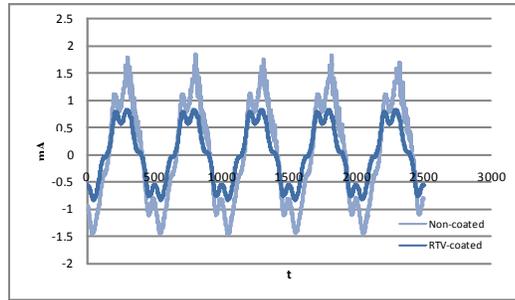
2) *Leakage current for kaolin polluted under salt fog condition (test 5-7):* Figure 8 compared typical leakage current waveforms for RTV Silicone Rubber coated insulator and non-coated ceramic insulator for kaolin pollution under salt fog with conductivity of 2 mS, 3 mS and 3.6 mS at applied voltage (a) 10 kV, (b) 35 kV and (c) 60 kV. For RTV Silicone Rubber coated insulator, at applied voltage from 10 – 60 kV, the leakage current waveform distortion was symmetrical at both polarity (positive and negative half cycles) and the 5th harmonics greatly contributed to the THD. This is similar to those observed for insulator polluted with kaolin-salt pollution under clean fog. On the contrary, for non-coated insulator, at applied voltage from 40 – 60 kV, the leakage current waveform distortion was asymmetrical. Spark was observed in positive half cycles. The 5th harmonics greatly contributed to the THD. Meanwhile the 3rd harmonic component is still insignificant.

Figure 8. Typical LC waveforms for insulator polluted with kaolin pollution under salt fog at applied voltage (a) 10 kV and (b) 60 kV

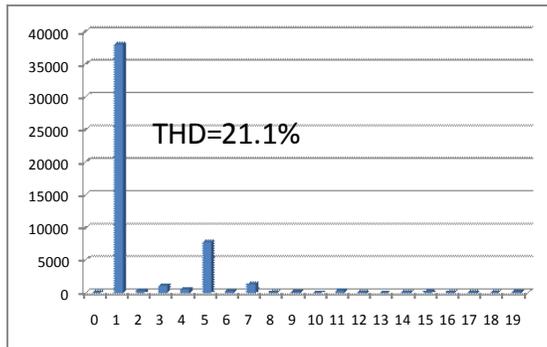
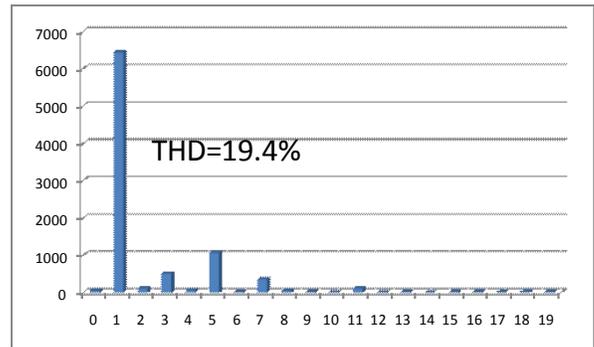
From Figure 9, it is clearly seen that the 3rd harmonic is very small compared to 5th harmonic. Figure 9 also shows that for the non-coated ceramic insulator at applied voltage 60kV, the 3rd harmonic is observed, though it is still small compared to 5th harmonic. The main difference between non-coated and RTV coated insulator are the fact that the 3th harmonic more significant than the 7<sup>th</sup> harmonic. These results are typical for polluted insulator with kaolin pollution under salt fog.

Figure 9. Typical harmonic components for (a) RTV coated insulators and (b) non-coated insulators polluted with kaolin pollution under salt fog at applied voltage 60 kV

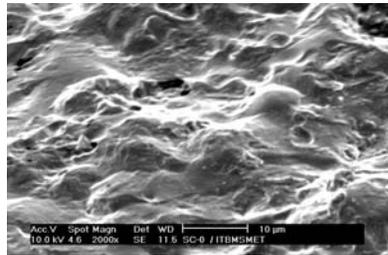
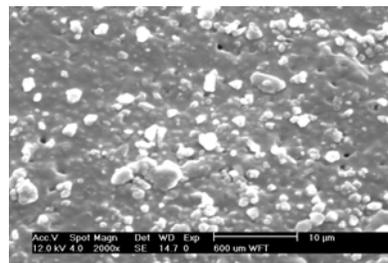
Surface smoothness of RTV silicone rubber coated insulator surface is indicated by Scanning Electron Microscopy (SEM) of the insulator surface. Figure 10 (a) shows SEM of non-coated clean ceramic insulator surface and (b) shows SEM of clean RTV silicone rubber coated insulator.

Figure 10. (a) SEM of non-coated clean ceramic insulator surface and (b) SEM of clean RTV silicone rubber coated insulator

From Figure 10, it is clearly seen that RTV silicone rubber coating increased the smoothness of insulator surface. Similar results had been found for silicone grease coated insulator. Both silicone based coated insulator has smoother surface and better hydrophobicity than the non-coated.

These results indicated RTV silicone rubber coatings improve surface smoothness. These results also indicated that smooth insulator surface tend to have good hydrophobicity. It is directly caused the leakage current flowed on insulator surface decreased. Insulator with good hydrophobicity could increase the flashover voltages, so there was not any flashover observed during experiments for applied voltage 60 kV. If insulator surface has smoother surface then it can be concluded that it has good hydrophobicity and higher surface resistance than the non-coated insulator.

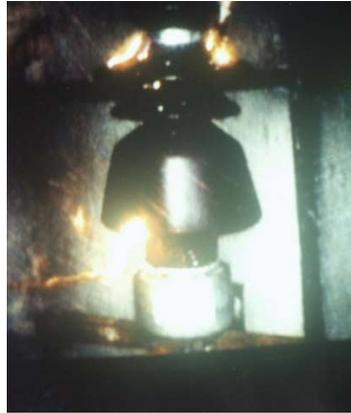
Under extreme polluted condition kaolin-salt 20mS/cm, under clean fog, non coated insulators, spark observed at 35 kV and flashover at applied voltage of about 50 kV. However, silicone-coated insulator did not show any flashover and spark until 60 kV for an hour test. Figure 11 shows typical insulator flashover. These experiments indicate that RTV silicone rubber coating increases flashover voltage of ceramic insulator under polluted condition. RTV Silicone Rubber coating successfully overcome some ceramic insulator weaknesses especially under certain environmental factors such as humidity, rainy season and pollution which may reduce their surface resistance. These results also indicate that the coating reduces leakage current and furthermore reduce dry band arcing that might occur on the ceramic insulator surface so there are no flashover observed of RTV Silicone Rubber coating insulator.

Figure 11. Flashover on the uncoated insulator
