Long Term Analysis of Cables Problems in Egyptian Distribution Network

Mohamed Shebl El-Bages, Mousa A. Abd-Allah, and M. Z. A. Elhawary

Electrical Engineering Dept., Faculty of Engineering at Shoubra,
Benha University, Egypt

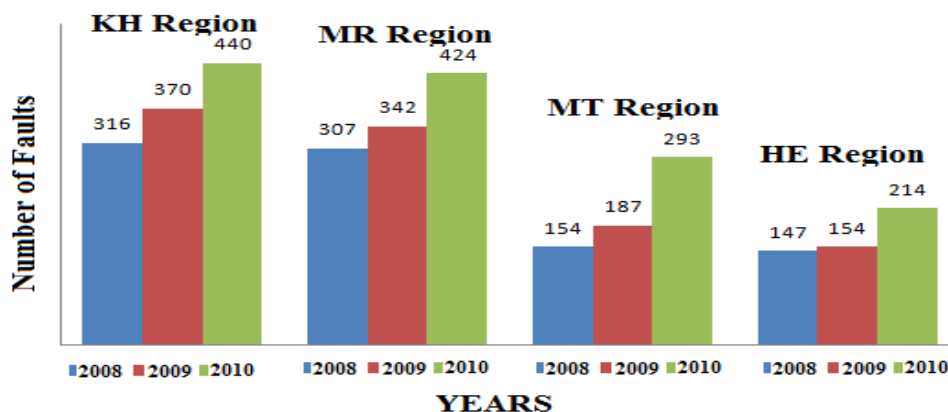
Figure 1. Rate of cable faults at different regions

Figure 1 shows the increasing rate of MV cable faults at different regions in the Egyptian distribution network and shows the importance of increasing the different skills to decreasing CML factor (Customer Minutes Lost is a method of measuring the performance of the network). The recording faults are taken in four different regions in the Great Cairo area where, KH is Al-Khanka region, MR is Al-Marg region, HE is Al-Helmia region and MT is Al-Mataria region. The recorded number of faults in KH, MR, HE, and MT regions in 2011 are 258, 450, 194 and 217 respectively.

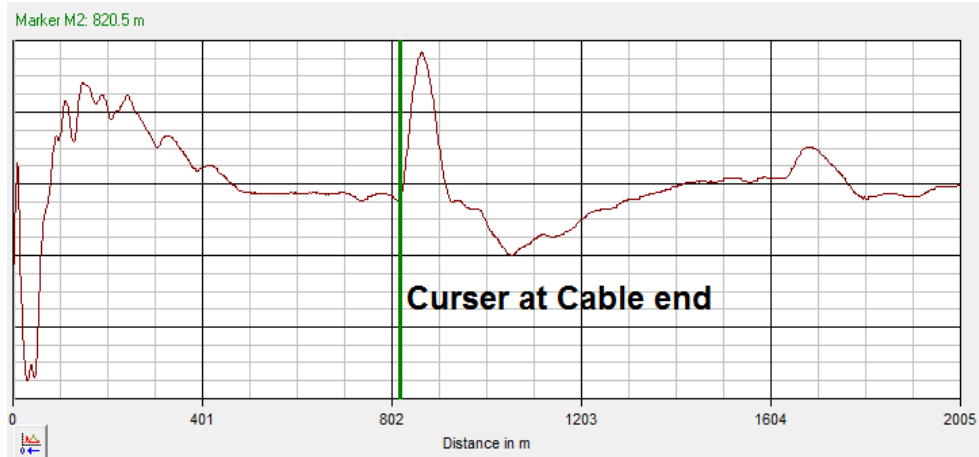
Figure 2a. Wave propagation on phase 1 (healthy phase)

Figures.(2a and c) show that the phases 1 and 3 are healthy and its length in the wave propagation is nearly at distance 820 m which equalized to cable length in cable mapping. Figure (3.b) shows that phase 2 has a fault at a distance of about 687m.

It can be noticed, from the figures, that the three phases have the same wave propagation characteristics (impedance change with distance along the cable length) and the wave propagation reflection sign is periodic.

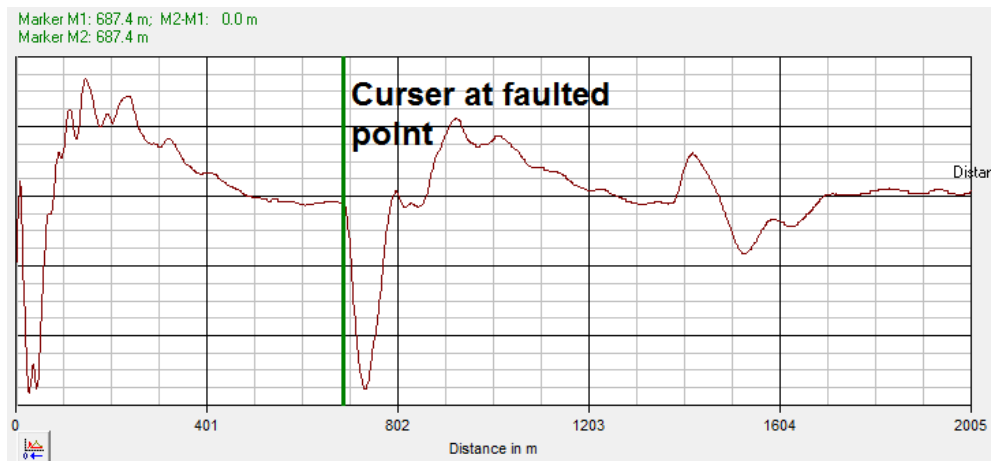
Figure 2b. Wave propagation on phase 2 (faulted phase)

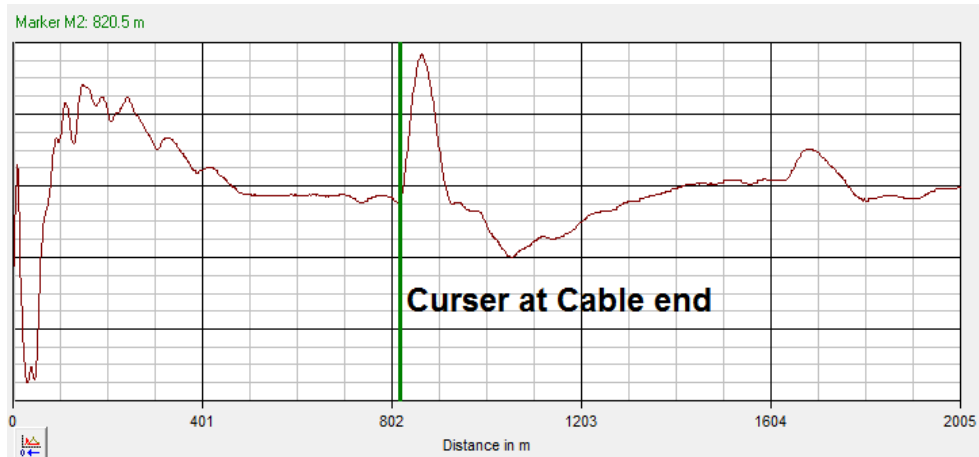
Figure 2c. Wave propagation on phase 3 (healthy phase)

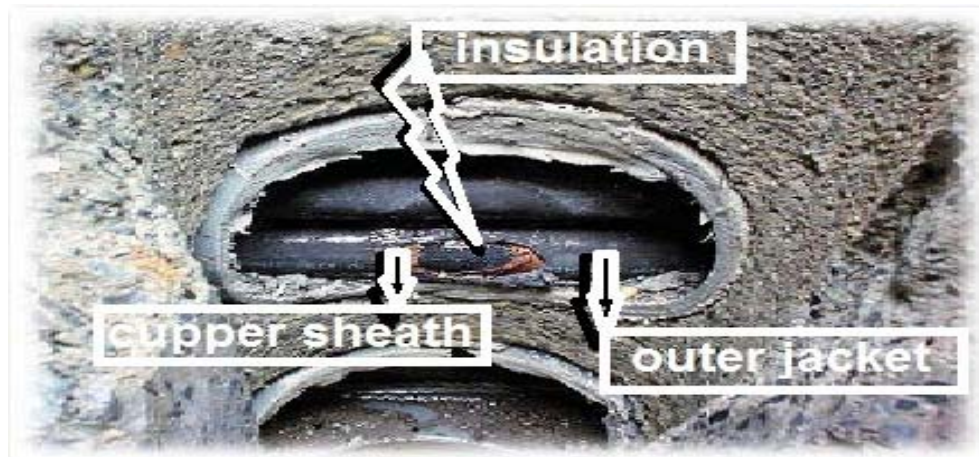
Figure 3. Faulted Cable

The cable under test is XLPE armored cable with a cross sectional areas of $3 \times 1 \times 400 \text{mm}^2$, shown in Figure (3). The test is performed at 28 October 2011. The outer jacket at the fault point is cutting during tracing the cable.

This cutting lead is due to corrosion in earth copper sheath, which lead to a burning and failure for the cable insulation in this region. This corrosion is due to the insulation absorption of water and moisture from the surrounding soil. As a result, the insulation becomes short circuited and burning. This cable has false tracing and lying because the cutting in the outer jacket and the neighbored cable is adhesion to the tested cable. This adhesive for cables are generate high fields, which have bad effect on these cables and reducing live time of the insulation and loading ratio.

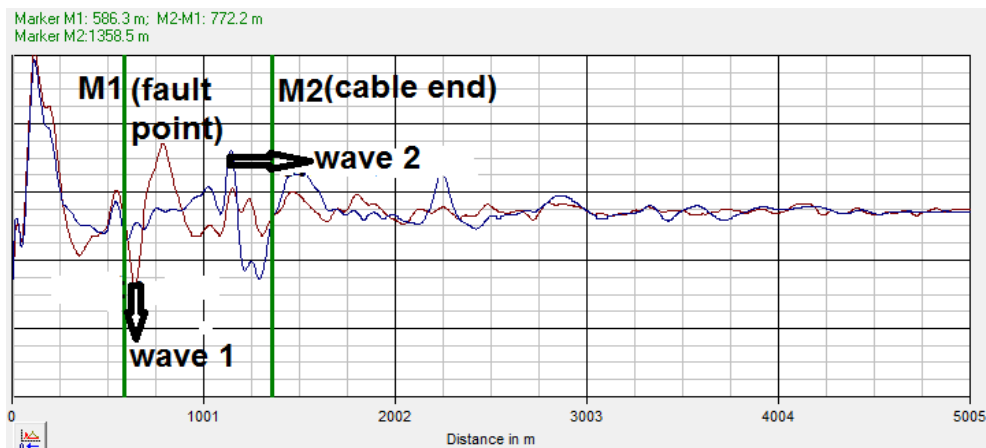
Figure 4. Wave propagation of the tested cable

The ARM is used in testing the faulted cable and the wave propagation result is shown in Figure 4. The figure shows the wave propagation of the two waves, the main wave (wave 1) and the secondary wave or fault wave (wave 2). The two waves are corresponding with each other until fault point, at which the main wave is reflected in a positive reflection and the faulted wave is reflected in a negative reflection. The reflection of the two waves will still opposite to each other until the end of the cable.

The two wave's reflections are return to corresponding and change with each other after the end of the cable (after cable length), means that distance of two opposite reflection equal to cable length.

The figure shows that the cable length is about 1300m from the cable mapping or a spelt already exist. Also, the length in the wave propagation at the Teleflex screen is 1358m at M2 marker at the cable end. The fault point is at a distance 586 m at M2 marker.

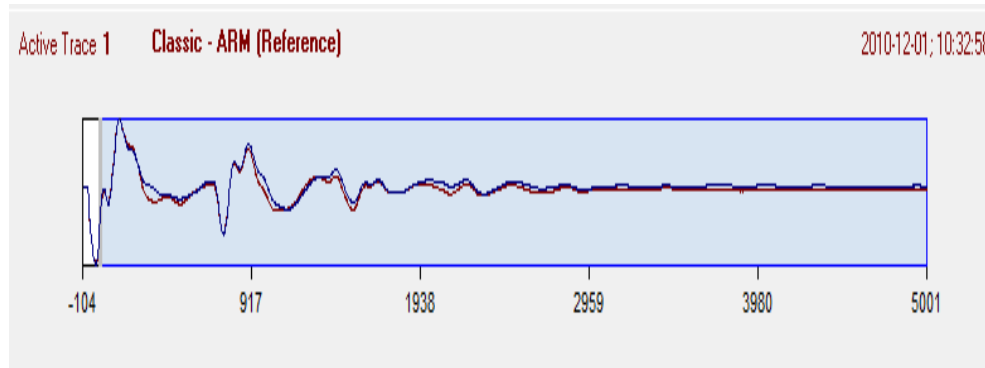
Figure 5. Wave propagation of cable by ARM

- 1- The ARM is used when the cable length is short.
- 2- Some cases of cable faults does not appear by ARM technique, because these cable are long or very low fault impedance as shown in Figure 5.

As shown in Figure 5, the propagations along the cable length of two waves (main wave and secondary wave) are similar, i.e. this method doesn't show the characteristic of the fault and the fault distance in pre-location of this cable cannot recognize. Another method as an impulse method or decay method must be used in this case.

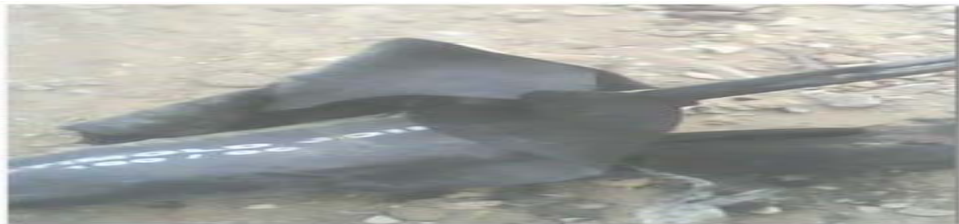
Figure 6. Faulted cable photograph before repairing

The cable under test is cutting its component separated from each other (outer jacket, insulation and conductor) which caused explosion in this point, as seen in Figure 6, the cable under test is XLPE cable with a cross sectional area of $3 \times 240 \text{ mm}^2$. The cable is tested at 20 Mach 2010.

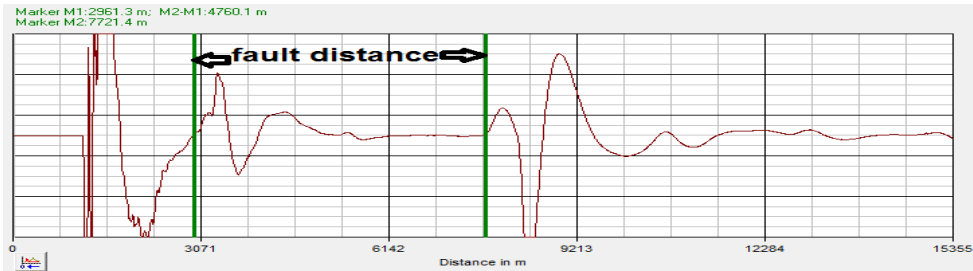
Figure 7. Wave propagation of faulted cable by using impulse method

Figure 7 shows that the fault distance in one periodic impulse is nearly 4760 m between the two cursers M1 and M2. This cable length from old maps is 9500 m, so the ARM did not used because the cable very long so that used impulse technique to determine the propagation characteristic.

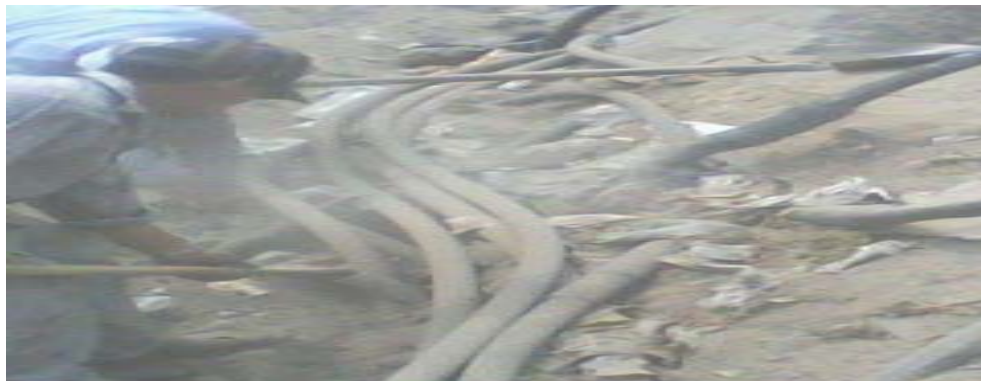
Figure 8. Faulted cable photograph before repairing

The cable under test is XLPE cable with a cross sectional area of $3 \times 1 \times 400 \text{mm}^2$. The faulted cable, shown in Figure 8, is tested in 28 September 2011. The faulted point of the cable is located at the cable insulation nearby the old joint, where many cables are laying on each other above the ground. This situation has very bad effects on the testing results, lifetime of these cables, and the loading ratio of the cables when operating.

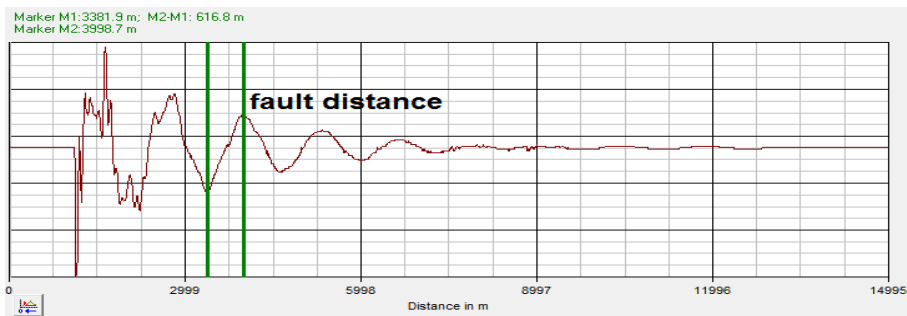
Figure 9. Wave propagation of faulted cable using decay method

Figure 9 shows that the wave propagation is periodic and the fault distance located between cursers M1 and M2 is about 620 m. The breakdown and flash over of this faulty cable is at 9 KV DC, the testing voltage is 18 KV DC and the operating voltage is 11 KV AC. It can be noticed that the cable seams as a healthy cable until 9 KV, at which the cable insulation will breakdown. This testing voltage and breakdown, or flashover, in cable insulation is not permeable in cable testing to ensure from the cable validity in the service.

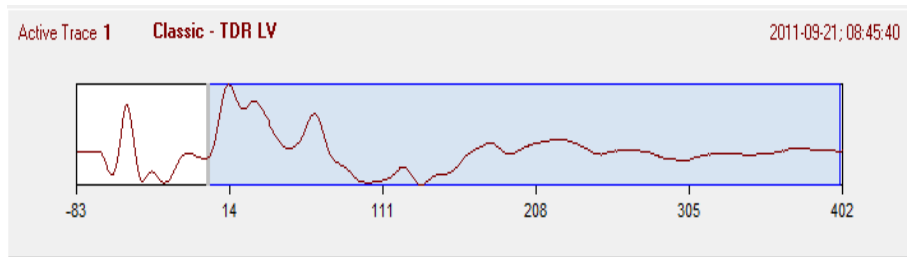
Figure 10. Wave propagation of faulty cable using TDR method

Figure 10 shows that the wave propagation using the TDR low voltage method. The wave propagation is non homogeneous and have difficult characteristics to determine the cable length and the faulty distance. When the cable tested by high voltage surge generator, the cable insulation is failed, so another method must be used to ensure from this test. The ARM technique is used as shown in Figure 11. The wave propagation by ARM is very easy and the cable fault is at a distance of 258m when main wave has negative reflection and secondary wave has positive reflection. The ARM method is success to determine the faulty distance as shown in Figure 11. To ensure from the results an impulse method can be used.

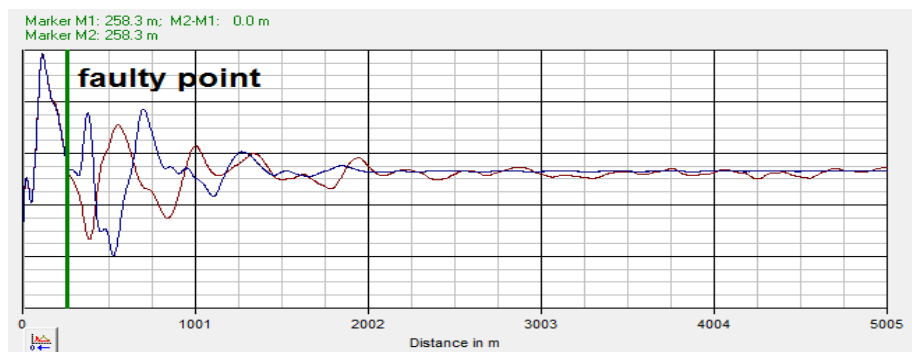
Figure 11. Wave propagation of faulty cable using ARM method

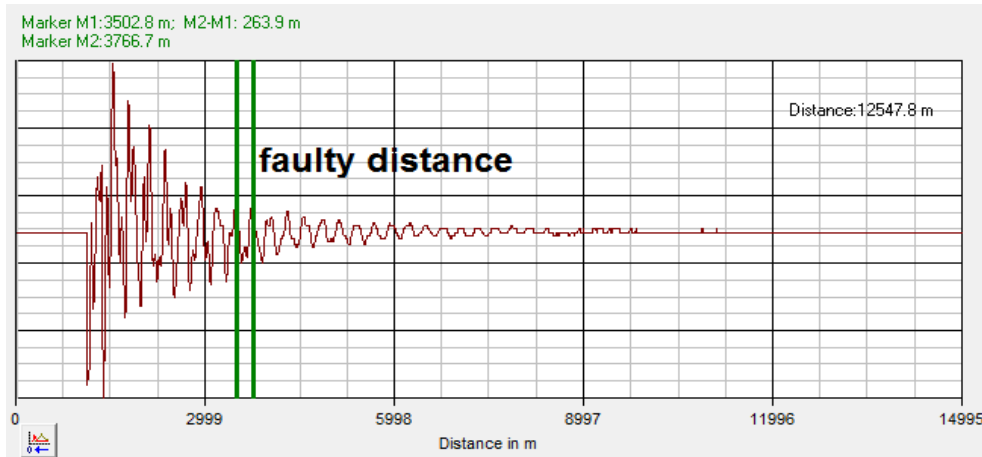
Figure 12. Wave propagation of faulty cable using ICE method

Figure 12 shows that the faulty distance with using the impulse method is about 263m which is nearly equal to the distance determined by ARM method.
